**4.3.5.2 Unit Type AP50-69.3.Y APPR 50-69 Unrenovated**

**Base Name:** Holloman Air Force Base

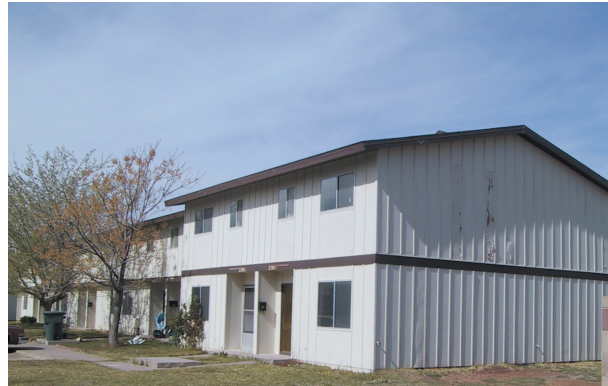
*Right side elevation*

- Exterior Wall Structure: wood frame; good condition.
- Exterior Wall Covering: wood batten board siding; deteriorated condition; paint is peeling from siding and in several places the siding has rotted at foundation level.
- Foundation/Basement: slab on grade; good condition.
- Floor Structure: joist; good condition; minor deflection at top of stairs.
- Windows - Frames: aluminum; deteriorated condition; dated windows, sliders difficult to operate.
- Windows - Glazing: single; deteriorated condition; bedroom windows do not provide emergency egress; poor insulating value.
- Windows - Screens: aluminum; poor condition.
- Doors - Entry: wood; fair condition; dated, flush door with many coats of paint.

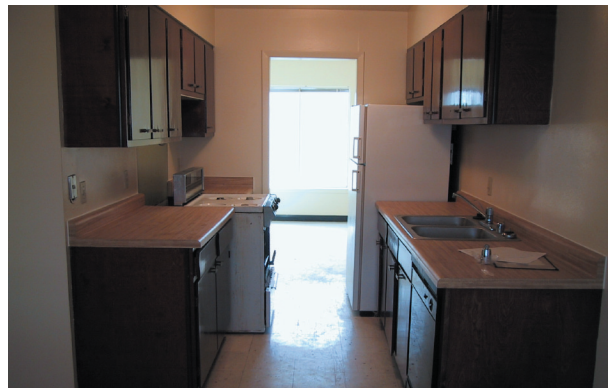
*Kitchen*

- Cabinets: wood; poor condition; dated cabinet with worn finishes.
- Counter Tops: laminated; fair condition; dated butcher-block pattern.
- Sink: stainless sink, double; poor condition; scratched finish.
- Sink Fixtures: metal; fair condition; scratched, stained.
- Refrigerator: standard; fair condition; worn interior.
- Range/Oven: gas; deteriorated condition; inoperable, broken down.
- Vent Hood: exhaust fan; deteriorated condition; dated through-wall unit.
- Dishwasher: standard; good condition.
- Garbage Disposal: standard; fair condition; worn; corroded case.
- Flooring: vinyl composite tile; poor condition; mismatching replacement tiles and separating tile joints.
- Walls: gypsum wall board; fair condition; some cracks.
- Wall Finish: painted; fair condition; aged appearance.

- Kitchen: enlarge Kitchen and provide a secondary eat-at counter; install new wood base and wall cabinets; provide new laminated counter tops; install new double bowl stainless steel sink and new fixture hardware; provide new refrigerator, gas range/oven, new garbage disposal and new vent hood/Kitchen exhaust with duct to outside louver; remove and patch opening from wall mounted fan; install ceramic tile flooring and base; install new gypsum wall board walls and ceiling due to condition and rewiring of unit; paint new gypsum wall board walls and ceiling install new toilet accessories; per proposed plan.

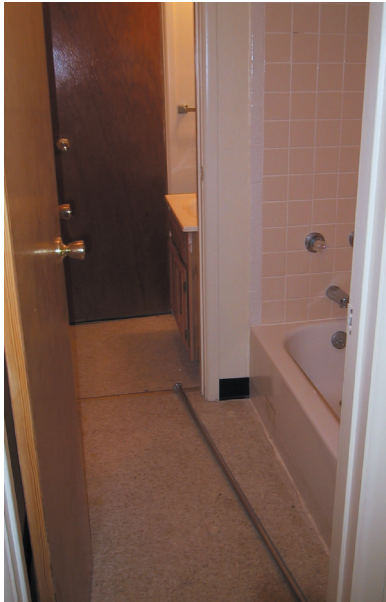
Bathroom 1

- Cabinets: wood; good condition.
- Counters: cultured marble; good condition.
- Sink: cultured marble; good condition.
- Fixture Hardware: metal; fair condition; worn finish.
- Toilet: porcelain; fair condition; aged.
- Tub/Shower: combination; fair condition; ceramic tile surround; aged; poor tile installation.
- Flooring: vinyl sheet; fair condition; metal transition strip damaged; worn.
- Walls: gypsum wall board; fair condition; uneven.
- Wall Finish: painted; fair condition; aged appearance.
- Ceilings: gypsum wall board; fair condition; uneven; patching visible.
- Ceiling Finish: painted; fair condition; aged appearance.
- Ventilation: exhaust fan; fair condition; noisy.
- Interior Hardware: chrome; fair condition; worn finish.

- Bathroom for Bedroom 1: reduce size of Bedroom 1 to enlarge bathroom; provide new wood vanity with cultured marble counter, molded bowl and new fixture hardware; install new toilet; install new tub/shower with ceramic tile surround; install ceramic tile flooring and base; provide new gypsum wall board walls and ceiling due to condition and rewire of unit; paint new gypsum wall board walls and ceiling; install new exhaust fan; provide duct to exterior louver; install new toilet accessories.

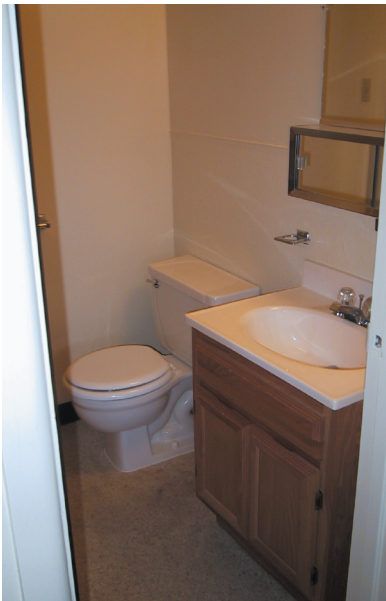
Bathroom 2

- Cabinets: wood; good condition.
- Counters: cultured marble; good condition.
- Sink: cultured marble; good condition.
- Fixture Hardware: metal; fair condition; worn.
- Toilet: porcelain; fair condition; aged.
- Tub/Shower: none; required to meet standard.
- Flooring: vinyl sheet; fair condition; metal transition strip damaged; worn, dated.
- Walls: gypsum wall board; fair condition; uneven.

- Bathroom for Bedroom 2,3,4: relocate due to the creation of master bathroom; provide new wood vanity with cultured marble counter, molded bowl and new fixture hardware; install new toilet; install new tub/shower with ceramic tile surround; install ceramic tile flooring and base; provide new gypsum wall board walls and ceiling due to condition and rewiring of unit; paint new gypsum wall board walls and ceiling; install new exhaust fan; provide duct and exterior louver; install new toilet accessories.

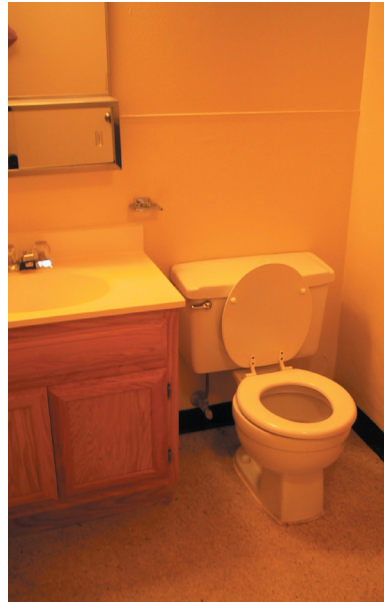
*Bathroom 3*

- Cabinets: wood; good condition.
- Counters: cultured marble; good condition.
- Sink: cultured marble; good condition.
- Fixture Hardware: metal; fair condition; corroded.
- Toilet: porcelain; good condition.
- Tub/Shower: none; not required.
- Flooring: vinyl sheet; poor condition; flooring worn.
- Walls: gypsum wall board; fair condition; uneven.
- Wall Finish: painted; fair condition; aged appearance.
- Ceilings: gypsum wall board; fair condition; some cracks.
- Ceiling Finish: painted; fair condition; aged appearance.
- Ventilation: exhaust fan; poor condition; older, noisy.
- Interior Hardware: metal; fair condition; worn finish.

- First Floor Bath for 2-Story House: provide separate half bath per proposed plan; install new sink fixture hardware; install new ceramic tile flooring and base; provide new gypsum wall board walls and ceiling due to condition and rewiring of unit; paint new gypsum wall board walls and ceiling; install new exhaust fan; provide duct and exterior louver; install new toilet accessories.

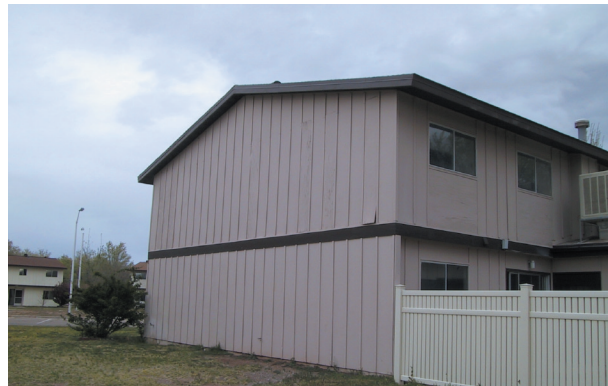
*Right side elevation*

- Exterior Wall Structure: wood frame; fair condition. 10 percent of exterior wall covering has deteriorated and has possibly caused minor damage to the wall structure.
- Exterior Wall Covering: vertical wood batten board siding; deteriorated condition; siding is splintered, pulled away from nails, curled up at edges and has paint peeling.
- Foundation/Basement: slab on grade; good condition.
- Floor Structure: joist; good condition.
- Windows - Frames: aluminum; deteriorated condition; window finish has corroded; sliders are hard to operate.
- Windows - Glazing: single; poor condition; windows are lacking proper weather-stripping; windows do not provide proper insulating value; bedroom windows provide emergency egress.

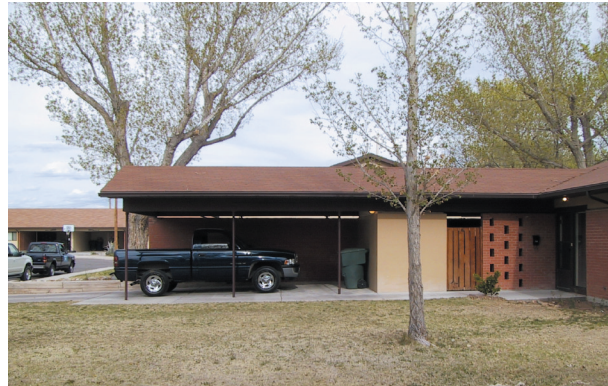
*Right side elevation*

- Exterior Wall Structure: wood frame; good condition.
- Exterior Wall Covering: brick; good condition; minor masonry cracking.
- Foundation/Basement: slab on grade; good condition.
- Floor Structure: none; slab on grade.
- Windows - Frames: aluminum; good condition.
- Windows - Glazing: double; good condition; bedroom windows provide emergency egress.
- Windows - Screens: aluminum; good condition.
- Doors - Entry: metal; fair condition; poor weather stripping.
- Doors - Sliding Glass: metal; good condition; patio doors; no secondary locking device.
- Doors - Storm/Screen: aluminum; good condition.
- Doors - Hardware: brass; good condition; entry door has no dead bolt.

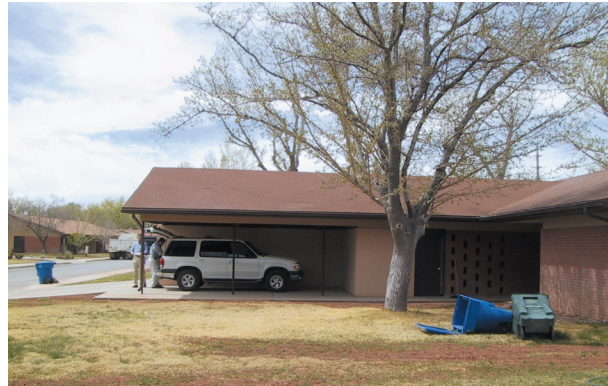
*Right side elevation*

- Exterior Wall Structure: wood frame; good condition.
- Exterior Wall Covering: stucco; fair condition; areas of cracking, discoloration and peeling paint; brick veneer is used as an accent; areas of deteriorating grout and discolored brick.
- Foundation/Basement: slab on grade; good condition.
- Floor Structure: none; slab on grade.
- Windows - Frames: aluminum; good condition.
- Windows - Glazing: double; good condition; bedroom windows provide emergency egress.
- Windows - Screens: aluminum; good condition.
- Doors - Entry: wood; fair condition; multiple coats of paint; dated.
- Doors - Sliding Glass: metal; fair condition; no secondary locking device.

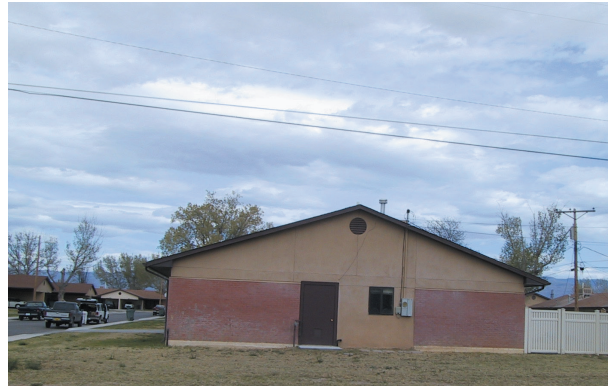
*Right side elevation*

- Exterior Wall Structure: wood frame; good condition.
- Exterior Wall Covering: stucco; good condition; brick veneer is used as an accent around house; brick has been discolored.
- Foundation/Basement: slab on grade; good condition.
- Floor Structure: none; slab on grade.
- Windows - Frames: aluminum; good condition.
- Windows - Glazing: double; good condition; bedroom windows provide emergency egress.
- Windows - Screens: aluminum; good condition.
- Doors - Entry: metal; good condition.
- Doors - Sliding Glass: aluminum; fair condition; no secondary locking device; some air penetration at Living Room and Family Room door.
- Doors - Storm/Screen: none; required; base standard to provide screen door.

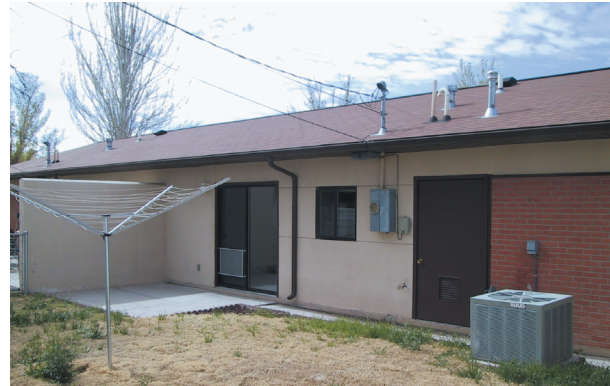
*Rear elevation*

- Exterior Wall Structure: wood frame; good condition.
- Exterior Wall Covering: stucco; fair condition; noted minor cracking and peeling paint from stucco with brick veneer accent.
- Foundation/Basement: slab on grade; good condition.
- Floor Structure: none; slab on grade.
- Windows - Frames: aluminum; good condition; minor corrosion of window finish from high alkali soil content.
- Windows - Glazing: double; good condition; bedroom windows provide emergency egress.
- Windows - Screens: aluminum; fair condition; screening has small holes.
- Doors - Entry: metal; fair condition; bad weather stripping.
- Doors - Sliding Glass: aluminum; fair condition; no secondary locking device; broken seal on glass panel.
- Doors - Storm/Screen: aluminum; fair condition; bad weather stripping.
- Doors - Hardware: brass; fair condition; no dead bolt on exterior doors.

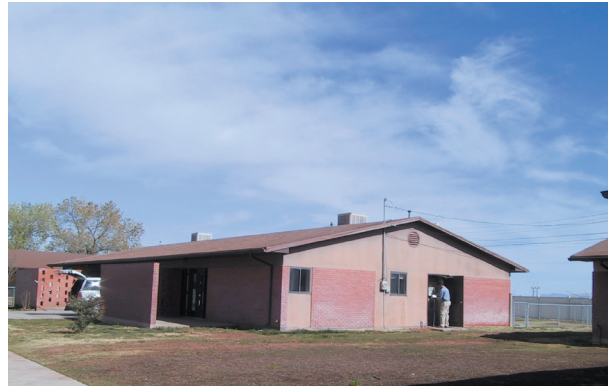
*Right side elevation*

- Exterior Wall Structure: wood frame; good condition.
- Exterior Wall Covering: stucco; fair condition; areas of cracking, discoloration and peeling paint; brick veneer is used as an accent; areas of deteriorating grout and discolored brick.
- Foundation/Basement: slab on grade; good condition.
- Floor Structure: none; slab on grade.
- Windows - Frames: aluminum; fair condition; window finish appears to be corroding.
- Windows - Glazing: double; good condition; bedroom windows provide emergency egress.
- Windows - Screens: aluminum; fair condition; screening is torn.
- Doors - Entry: wood; fair condition; multiple coats of paint; an atrium door leads out to the front patio from the Living Room; doors are in fair condition.
